QUARTERLY LANDFILL ENGINEERING INSPECTION REPORTS

**WATERBURY LANDFILL
QUARTERLY INSPECTION
FIRST QUARTER 2005**

WATERBURY LANDFILL
QUARTERLY INSPECTION

WATERURY LANDFILL

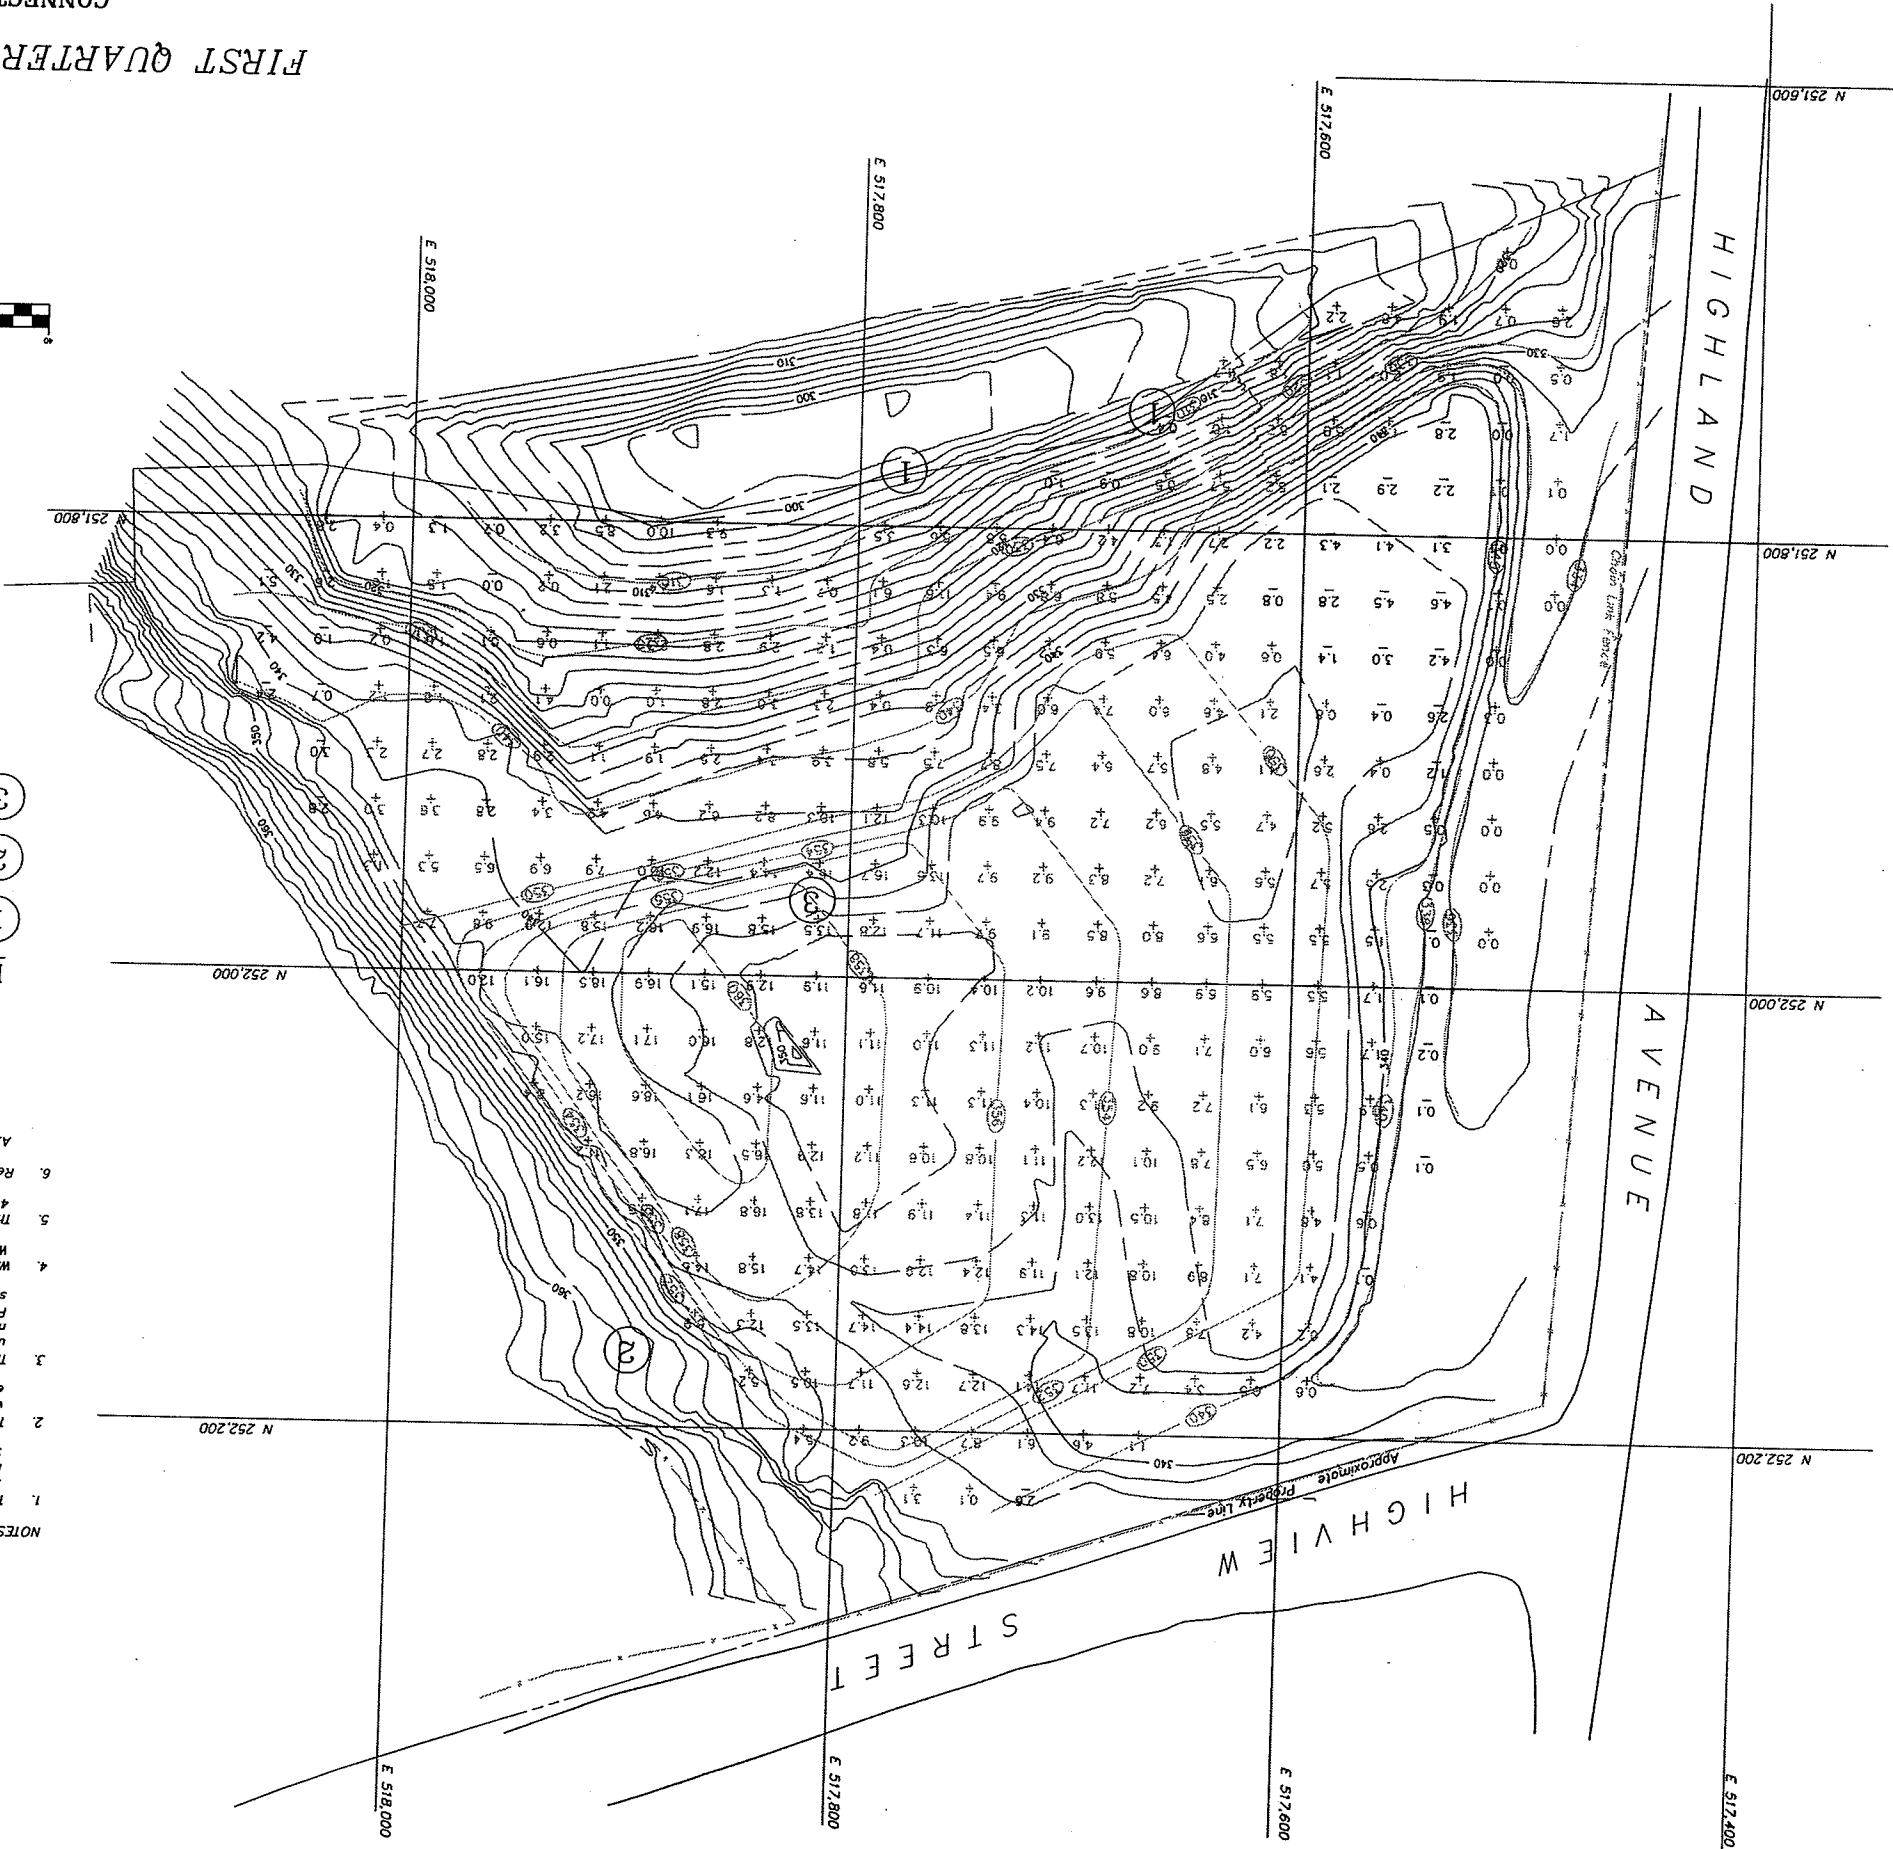
FIRST QUARTER INSPECTION REPORT 2005

4. **Cover Soils, Vegetation, and Grading** - Cover soils in all areas appeared to be adequate. No exposed waste was observed. Vegetation is established over most of the south and west portions of the landfill. The vegetation has stabilized the steep slopes. The grades at the top of the most recent working area are satisfactory. The grades along the south slope are greater than 3:1. This slope will have to be corrected when the landfill is capped.

At the request of CTDEP, CRAA installed and/or marked the property corners of the solid waste disposal area. Based on the location of the property corners, it is evident that a portion of the southerly toe of the landfill extends beyond the property boundary (see site plan area 1). On May 27, 2004, representatives from CRAA and CTDEP met on site to discuss this issue. CRAA informed CTDEP that it had searched the City of Waterbury land records and was unable to find an owner of record for the affected property, and was only able to confirm that the affected property was an abandoned rail right-of-way. CRAA informed CTDEP that the owner of the landfill, the Bridgeport Project was in the process of selecting a consultant to analyze the potential operational options for the landfill. Currently, the consultant is analyzing various options for the landfill. In the meantime, the Bridgeport Project Board of Directors has directed CRAA to resume operation of the landfill and fill it to its current permitted capacity during fiscal year 2006 (July 1, 2005 through June 30, 2006). Once the operation resumes, CRAA will direct its operator to correct the waste location and grading problem. CRAA anticipates the landfill will be filled to its currently permitted capacity by the end of fiscal year 2006.

5. **Drainage and Erosion Control** – Stormwater from the site collects in a low-lying area to the south of the landfill via overland flow and a large rip-rap swale, where it percolates into the ground. The access roadway on the north side of the landfill was eroded and the contractor was notified that a repair was necessary. The contractor repaired the erosion during the first week of January 2005 (see site plan area 2). Additional erosion was observed and will be repaired during the second quarter 2005. The large rip-rap swale along the southeast side of the landfill is in good condition, but overgrown in some places with brush. The brush will be monitored and removed as necessary to allow for proper function of the swale. A small amount of erosion was observed at the top of the southern slope. However, no repair is necessary at this time. (see site plan area 3).

- INSPECTION NOTES**
- ① WASTE LOCATION BEYOND PROPERTY LINE
 - ② EROSION IN ACCESS ROAD
 - ③ SMALL AREA OF EROSION TO OBSERVE

1. Address waste location issue once landfill resumes operation.
2. Repair erosion on access road.
3. Ensure groundwater monitoring consultant secures well MW-A.

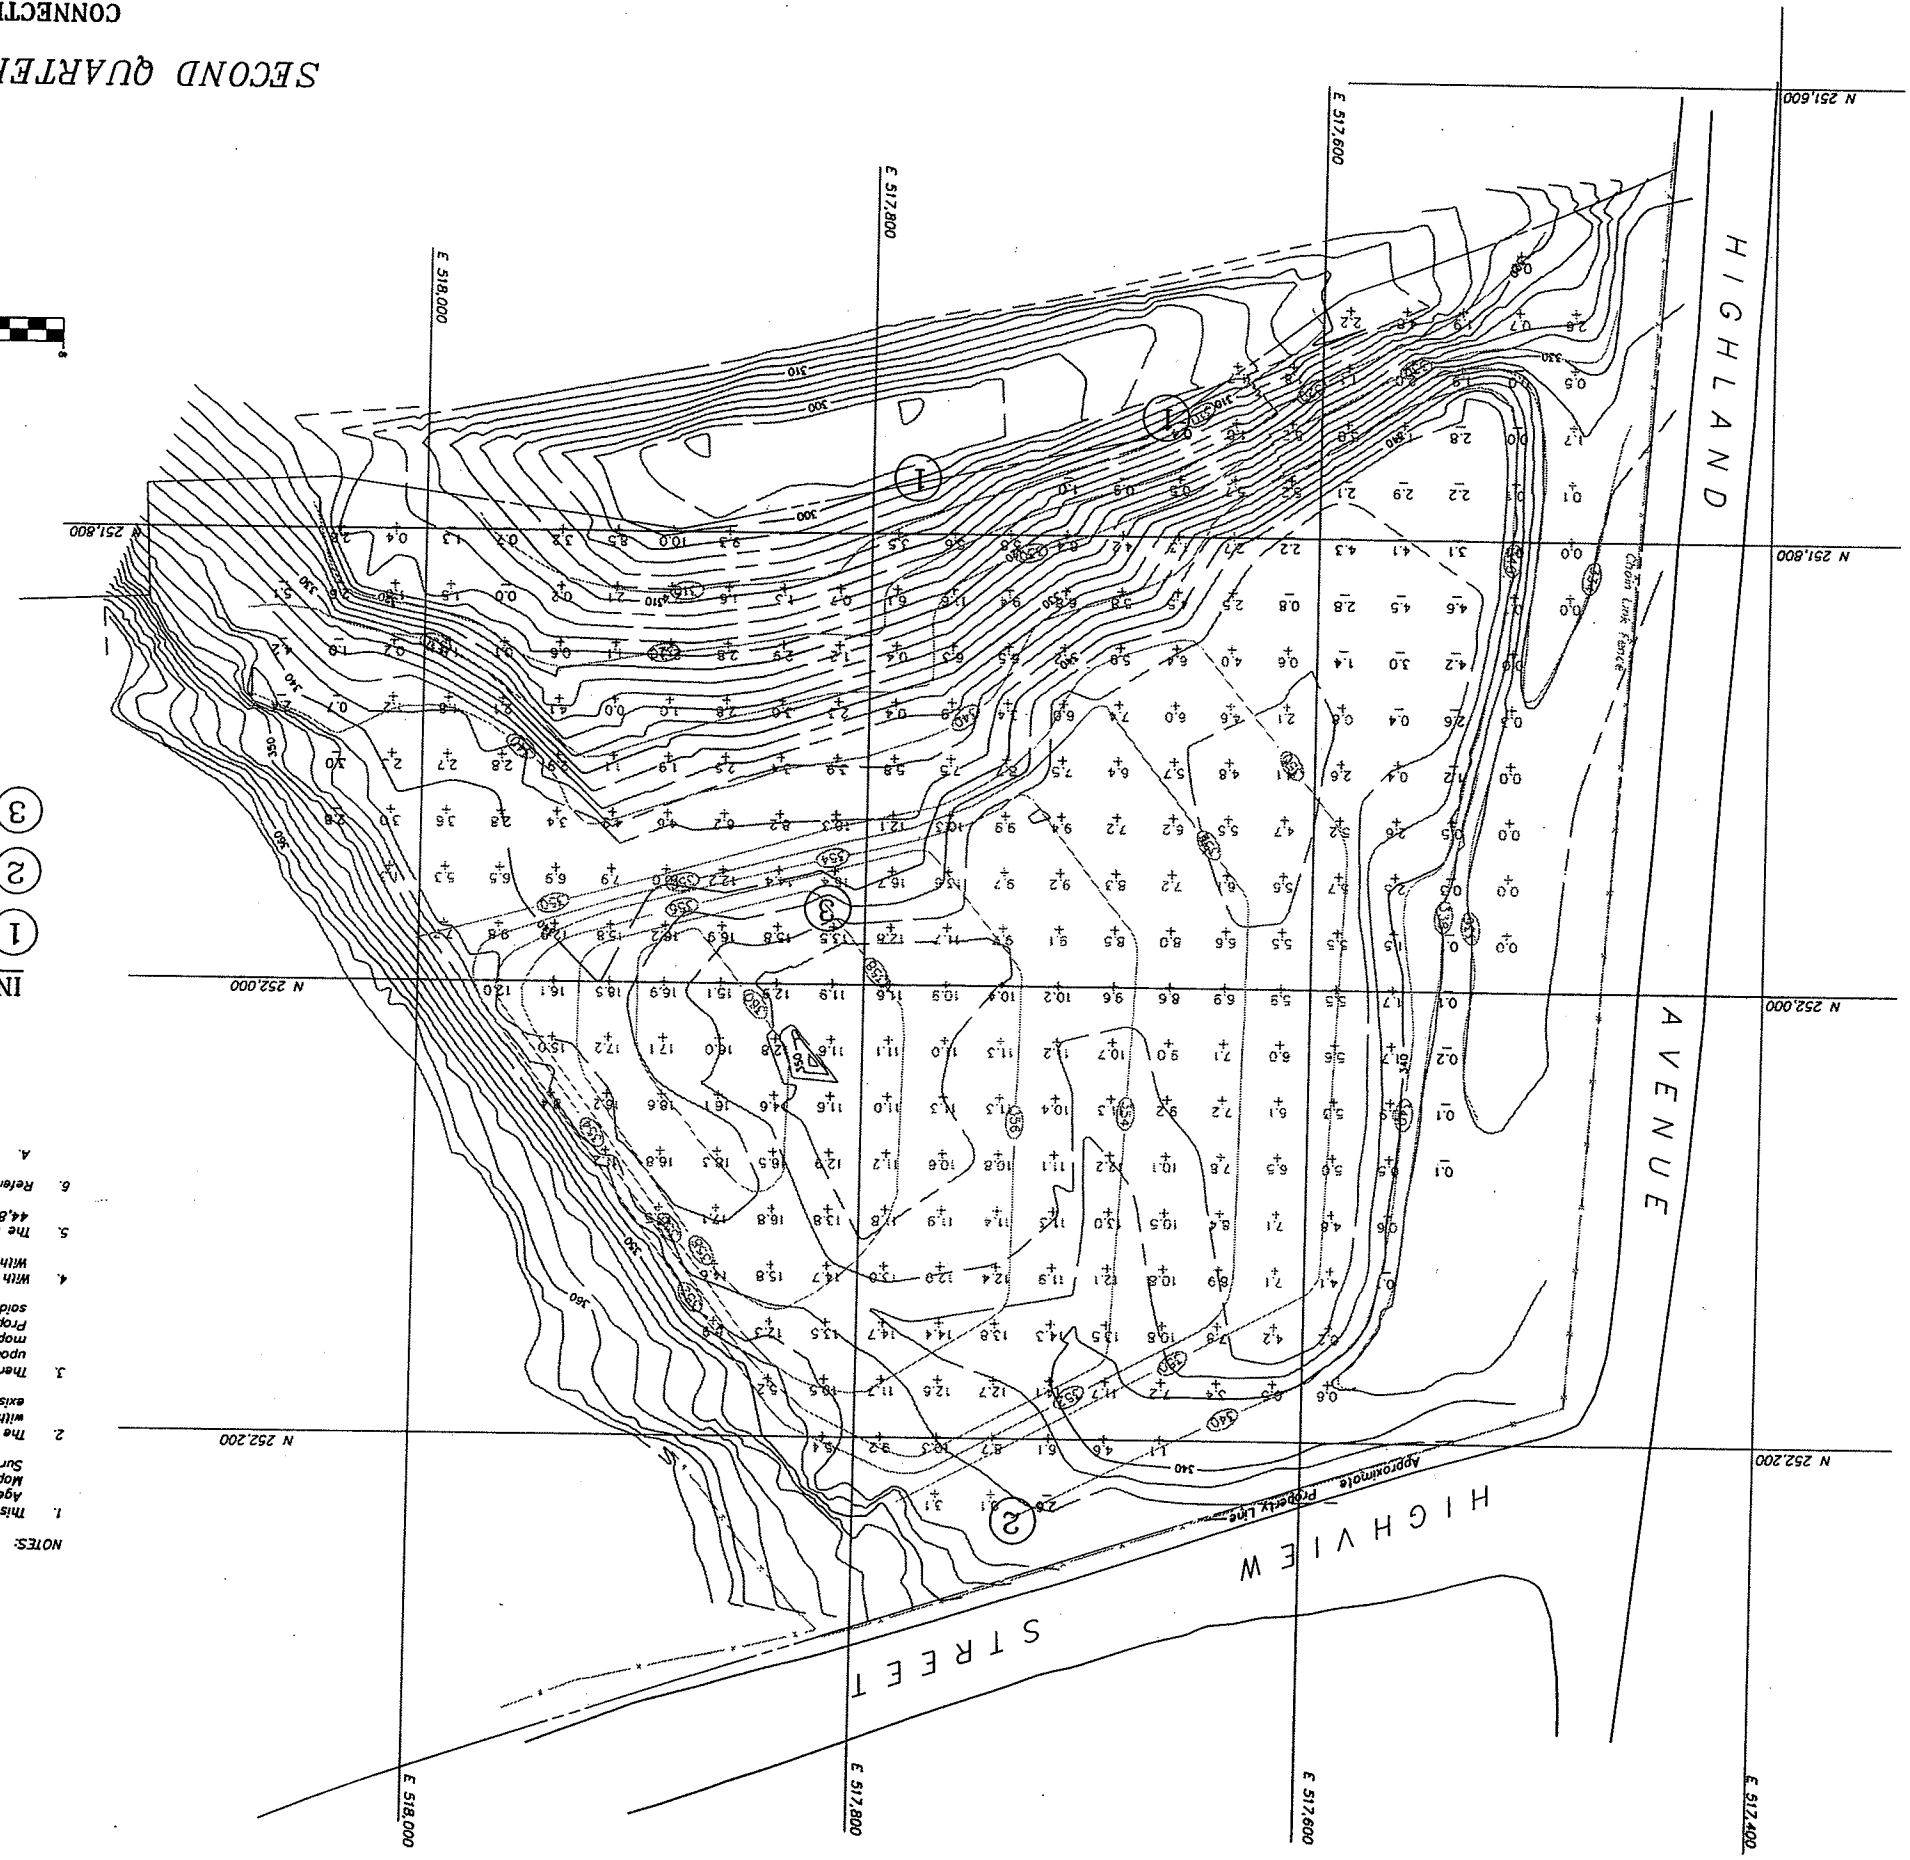
WATERURY LANDFILL
 SECOND QUARTER INSPECTION REPORT 2005

4. **Cover Soils, Vegetation, and Grading** - Cover soils in all areas appeared to be adequate. No exposed waste was observed. Vegetation is established over most of the south and west portions of the landfill. The vegetation has stabilized the steep slopes. The grades at the top of the most recent working area are satisfactory. The grades along the south slope are greater than 3:1. This slope will have to be corrected when the landfill is capped.

At the request of CTDEP, CRAA installed and/or marked the property corners of the solid waste disposal area. Based on the location of the property corners, it is evident that a portion of the southerly toe of the landfill extends beyond the property boundary (see site plan area 1). On May 27, 2004, representatives from CRAA and CTDEP met on site to discuss this issue. CRAA informed CTDEP that it had searched the City of Waterbury land records and was unable to find an owner of record for the affected property, and was only able to confirm that the affected property was an abandoned rail right-of-way. CRAA informed CTDEP that the owner of the landfill, the Bridgeport Project was in the process of selecting a consultant to analyze the potential operational options for the landfill. Currently, the consultant is analyzing various options for the landfill. In the meantime, the Bridgeport Project Board of Directors has directed CRAA to resume operation of the landfill and fill it to its current permitted capacity during fiscal year 2006 (July 1, 2005 through June 30, 2006). Once the operation resumes, CRAA will direct its operator to correct the waste location and grading problem. CRAA anticipates the landfill will be filled to its currently permitted capacity by the end of fiscal year 2006.

5. **Drainage and Erosion Control** – Stormwater from the site collects in a low-lying area to the south of the landfill via overland flow and a large rip-rap swale, where it percolates into the ground. The access roadway on the north side of the landfill was again eroded (see site plan area 2). CRA will notify the contractor that a repair is necessary. The large rip-rap swale along the southeast side of the landfill is in good condition, but overgrown in some places with brush. The brush will be monitored and removed as necessary to allow for proper function of the swale. A small amount of erosion was observed at the top of the southern slope. However, no repair is necessary at this time. (see site plan area 3).

- INSPECTION NOTES**
- ① WASTE LOCATION BEYOND PROPERTY LINE
 - ② EROSION IN ACCESS ROAD
 - ③ SMALL AREA OF EROSION TO OBSERVE

1. Address waste location issue once landfill resumes operation.

2. Repair erosion on access road.

3. Ensure groundwater monitoring consultant secures well MW-A

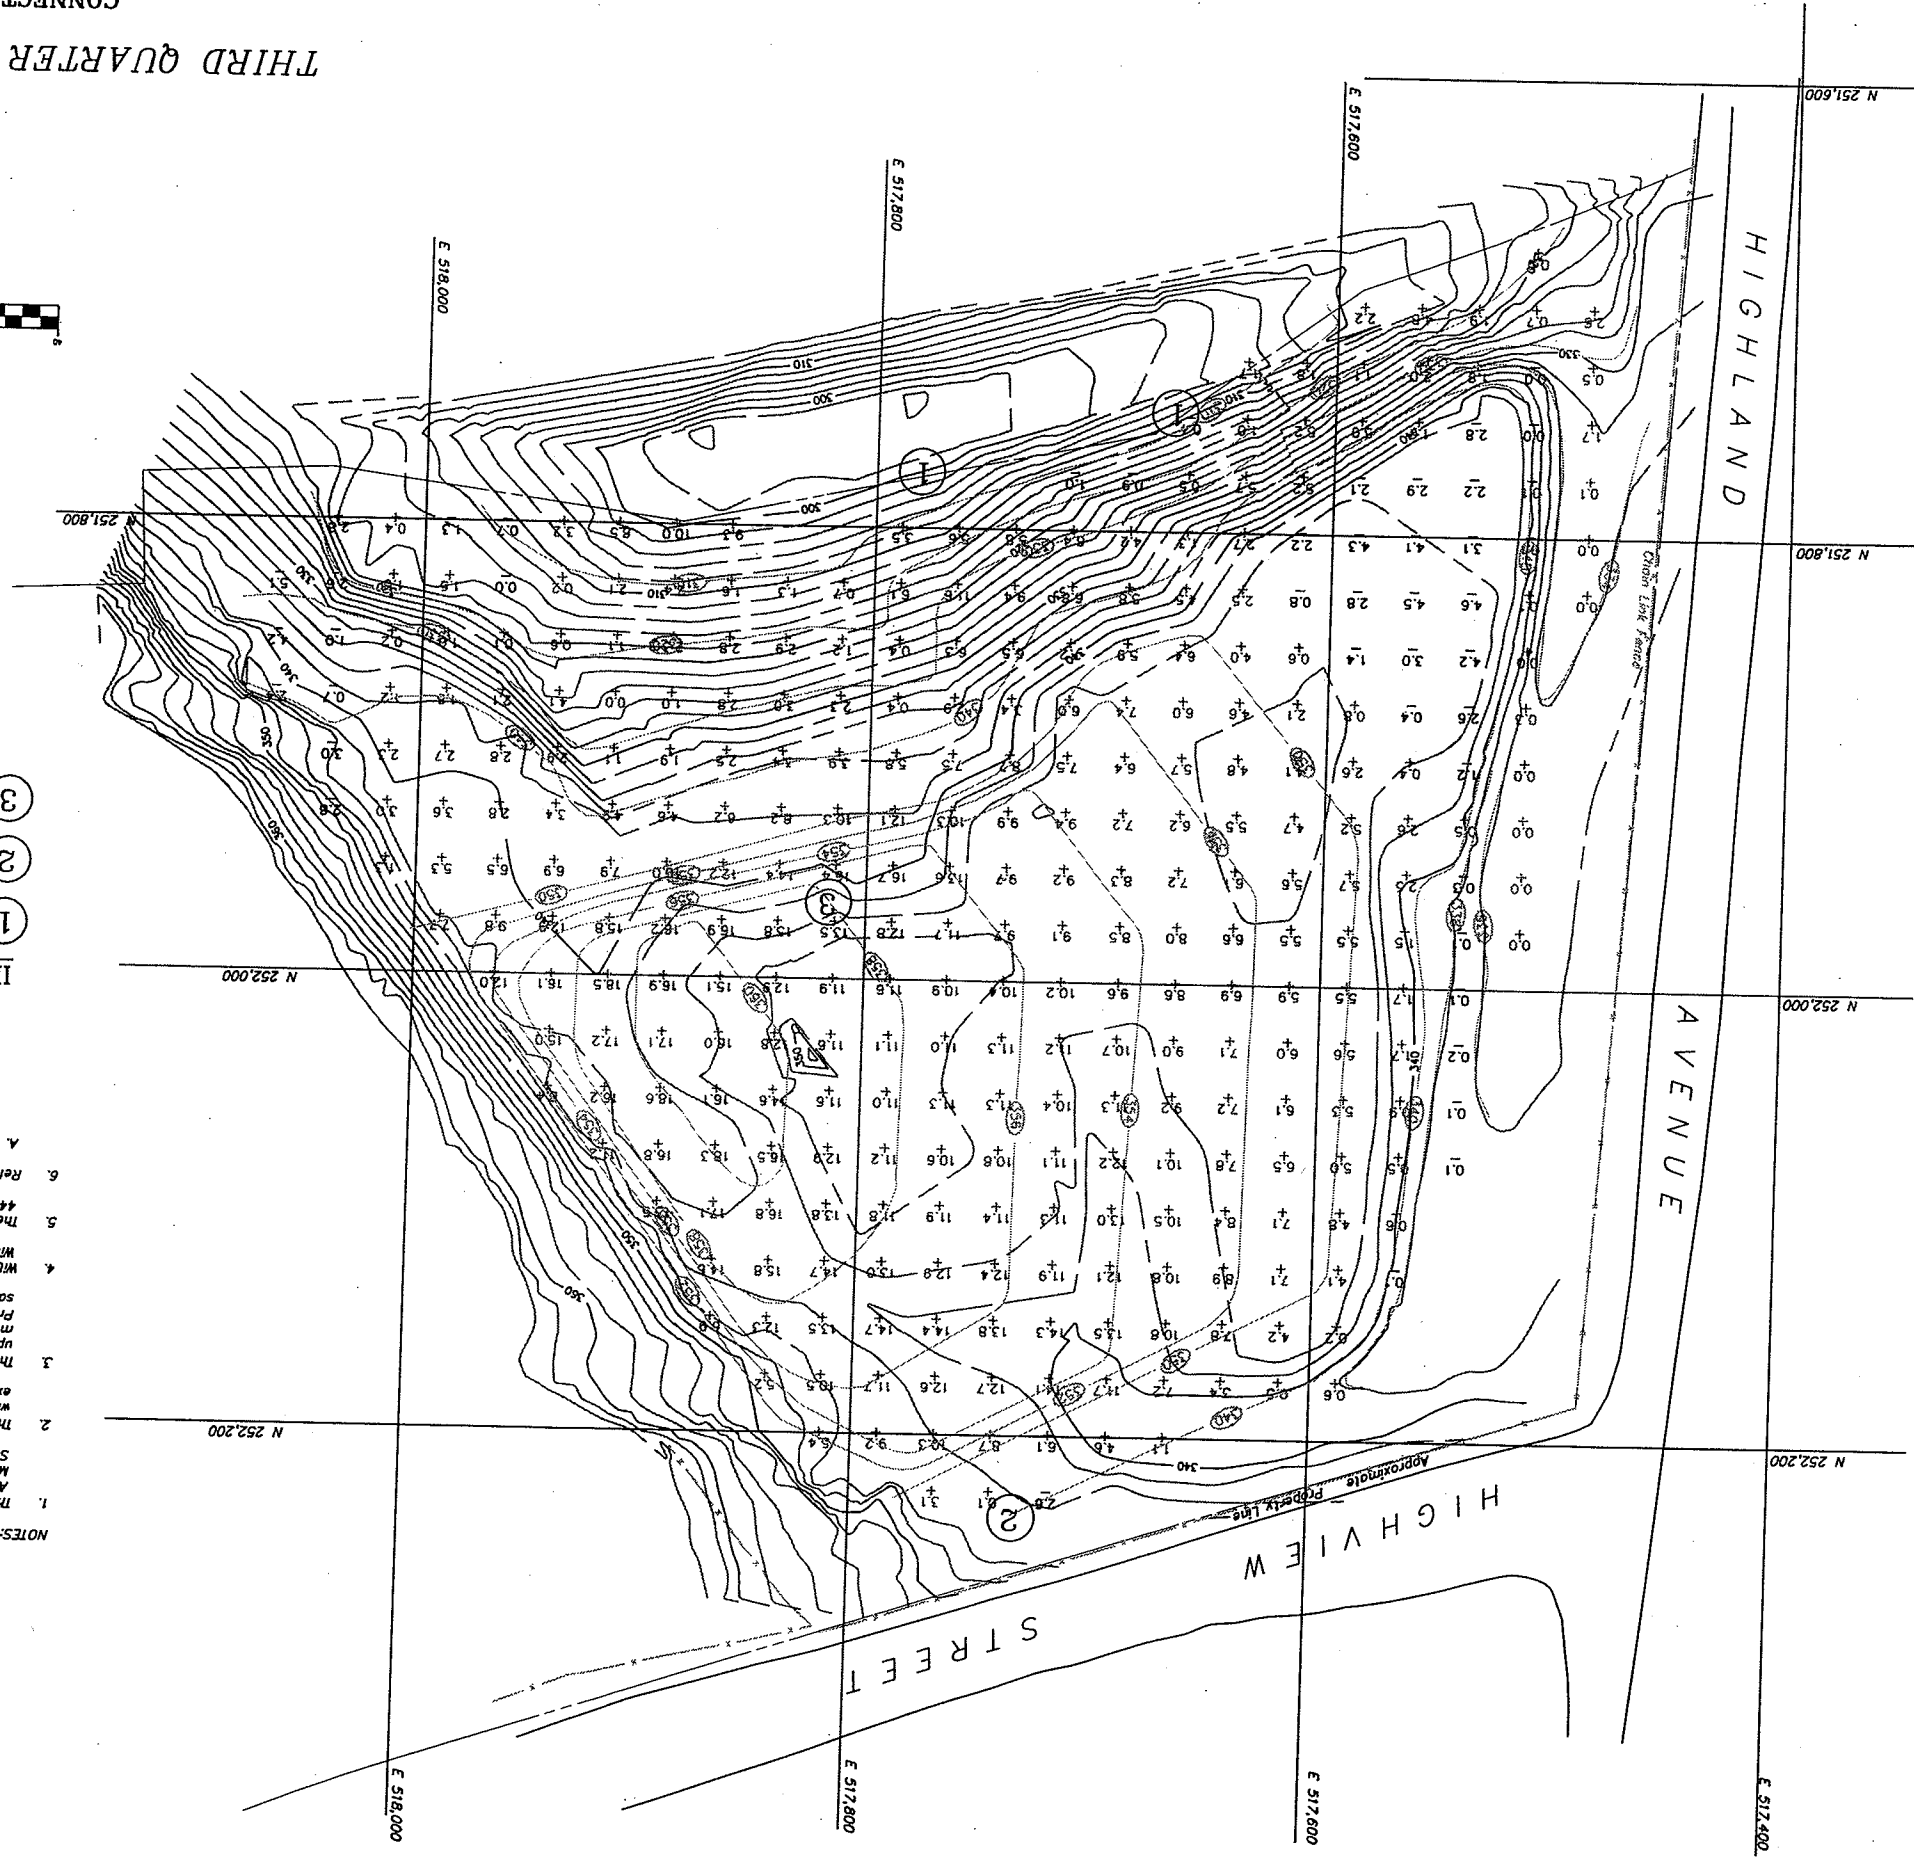
THIRD QUARTER INSPECTION REPORT 2005

1. **Odors** - No odors were present during the inspection. Previous inspection reports do not indicate any odor problems.
2. **Dust Control** - No dust was present from landfill operations. Previous inspection reports do not indicate dust problems associated with the landfill operation.
3. **Working Area** - The grade of the most recent working area appeared to be generally acceptable.
4. **Cover Soils, Vegetation, and Grading** - Cover soils in all areas appeared to be adequate. No exposed waste was observed. Vegetation is established over most of the south and west portions of the landfill. The vegetation has stabilized the steep slopes. The grades at the top of the most recent working area are satisfactory. The grades along the south slope are greater than 3:1. This slope will have to be corrected when the landfill is capped.

At the request of CTDEP, CRAA installed and/or marked the property corners of the solid waste disposal area. Based on the location of the property corners, it is evident that a portion of the southerly toe of the landfill extends beyond the property boundary (see site plan area 1). On May 27, 2004, representatives from CRAA and CTDEP met on site to discuss this issue. CRAA informed CTDEP that it had searched the City of Waterbury land records and was unable to find an owner of record for the affected property, and was only able to confirm that the affected property was an abandoned rail right-of-way. CRAA informed CTDEP that the owner of the landfill, the Bridgeport Project was in the process of selecting a consultant to analyze the potential operational options for the landfill. Currently, the consultant is analyzing various options for the landfill. In the meantime, the Bridgeport Project Board of Directors has directed CRAA to resume operation of the landfill and fill it to its current permitted capacity during fiscal year 2006 (July 1, 2005 through June 30, 2006). Once the operation resumes, CRAA will direct its operator to correct the waste location and grading problem. CRAA anticipates the landfill will be filled to its currently permitted capacity by the end of fiscal year 2006.

5. **Drainage and Erosion Control** – Stormwater from the site collects in a low-lying area to the south of the landfill via overland flow and a large rip-rap swale, where it percolates into the ground. The access roadway on the north side of the landfill was repaired during the last quarter, but again eroded (see site plan area 2). CRAA will notify the contractor that a repair is necessary. The large rip-rap swale along the southeast side of the landfill is in good condition, but overgrown in some places with brush. The brush will be monitored and removed as necessary to allow for proper function of the swale. A small amount of erosion was again observed at the top of the southern slope. However, no repair is necessary at this time. (see site plan area 3).

- INSPECTION NOTES**
- ① WASTE LOCATION BEYOND PROPERTY LINE
 - ② EROSION IN ACCESS ROAD
 - ③ SMALL AREA OF EROSION TO OBSERVE

1. Address waste location issue once landfill resumes operation.
2. Repair erosion on access road.
3. Ensure groundwater monitoring consultant secures well MW-A.

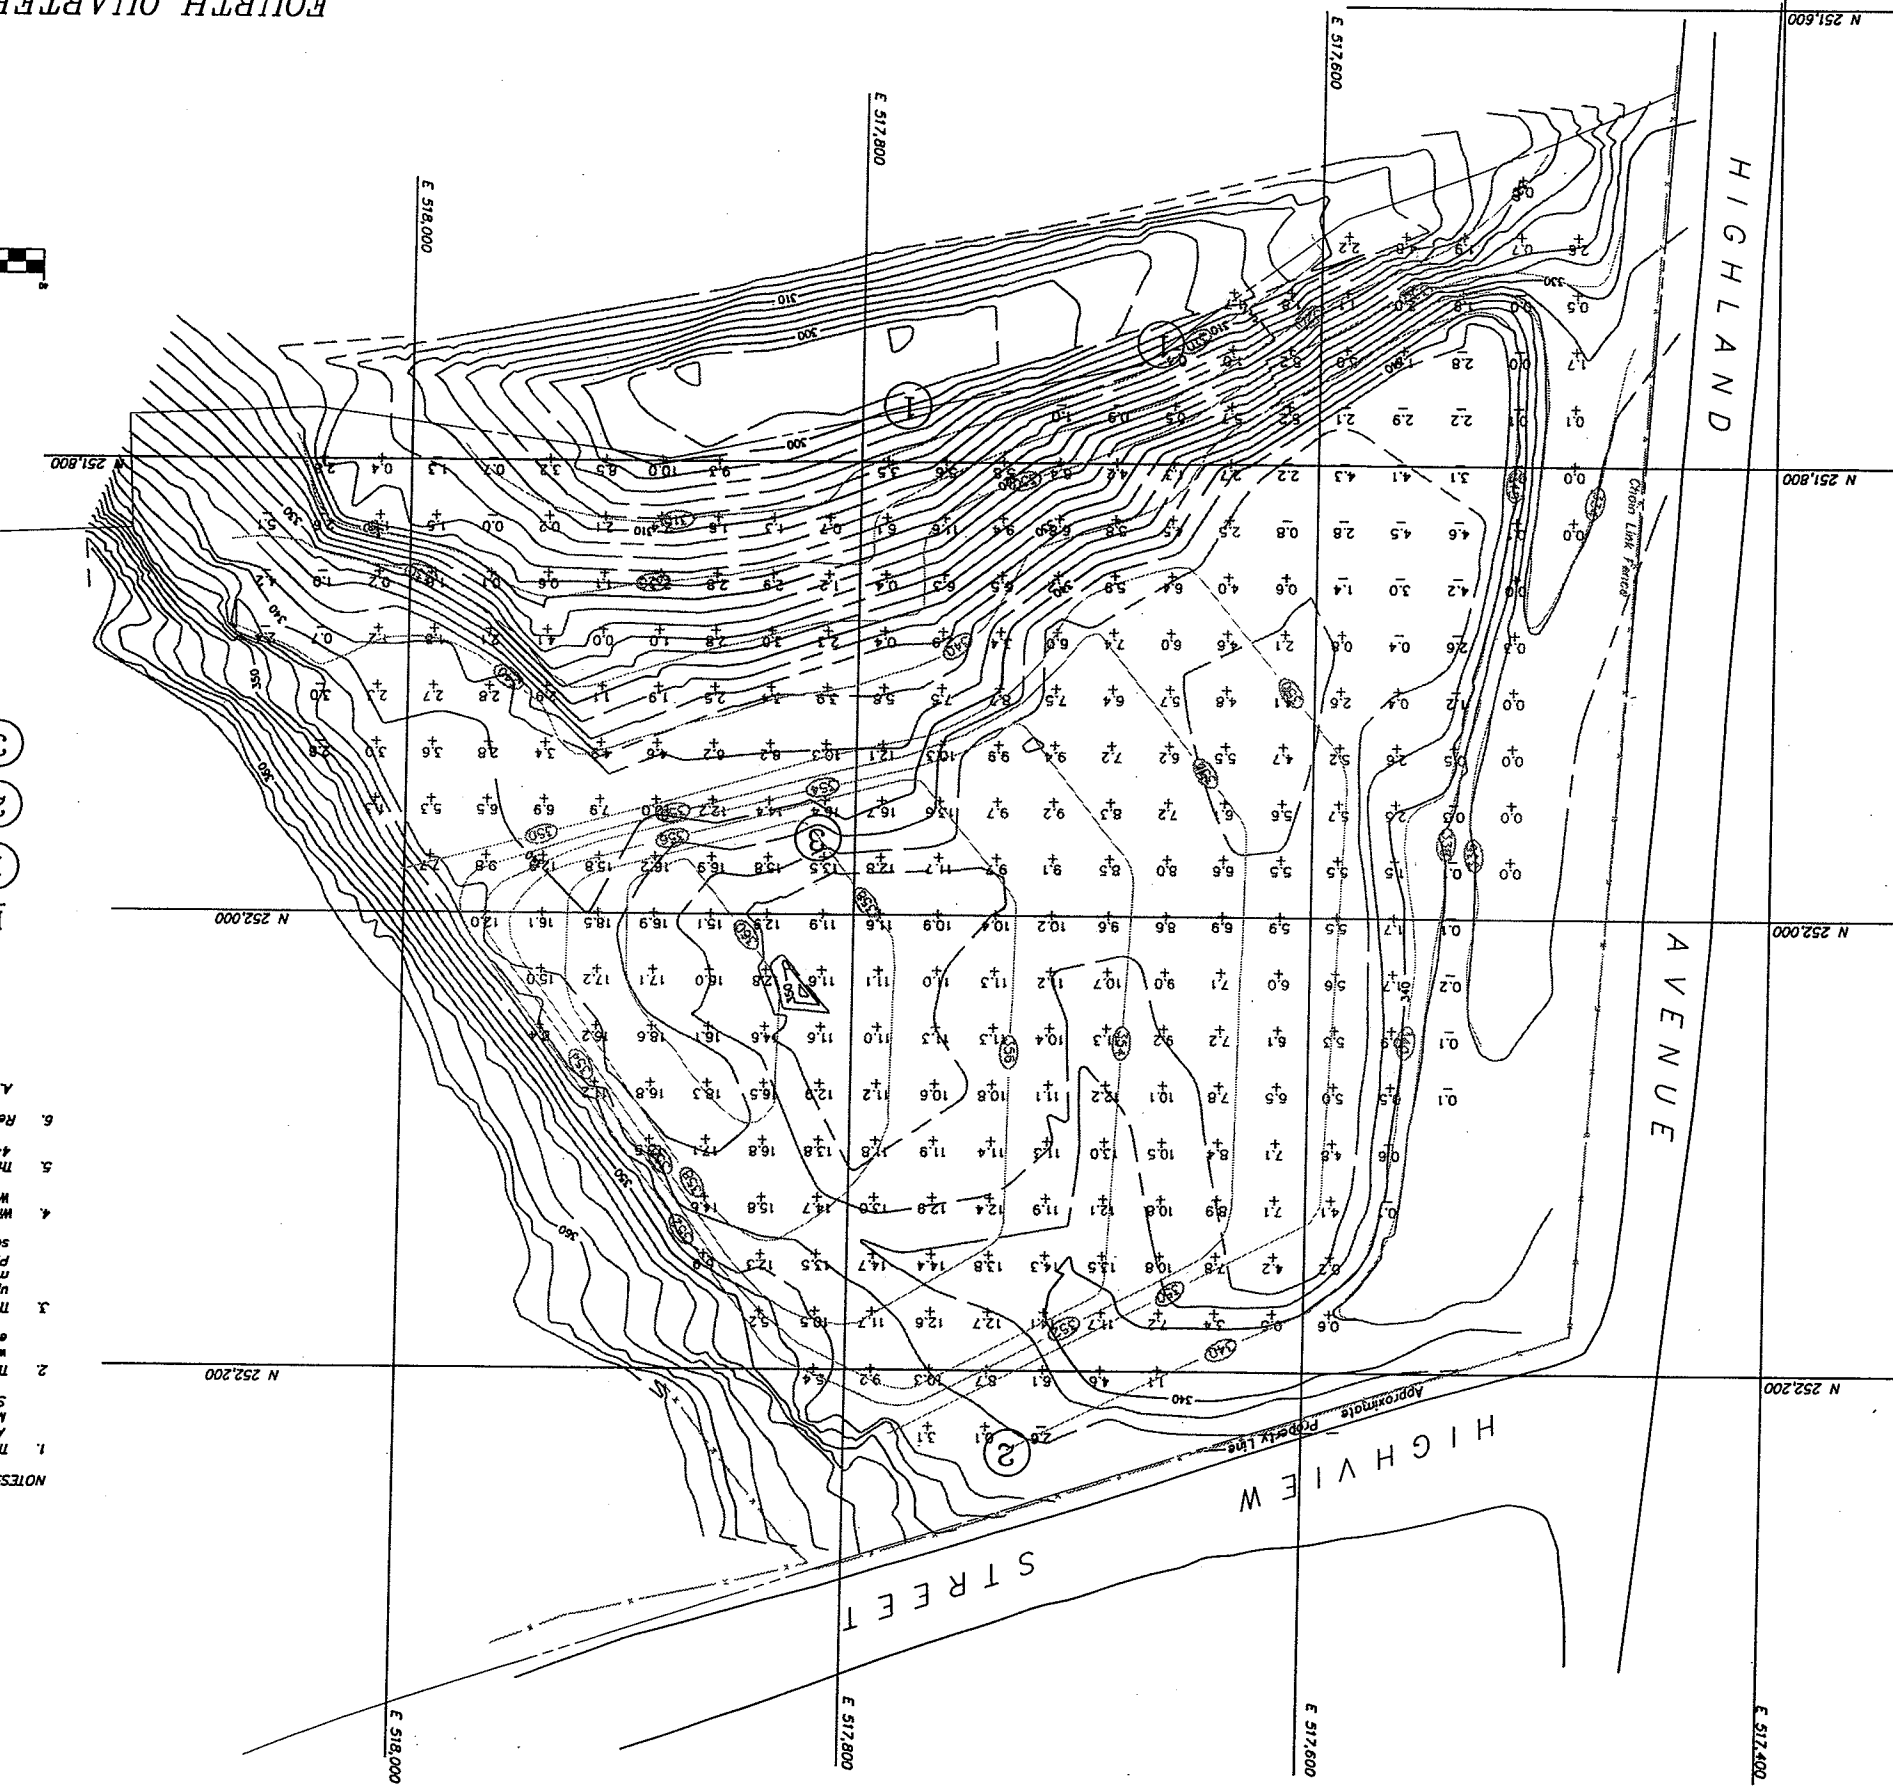
FOURTH QUARTER INSPECTION REPORT 2005

4. **Cover Soils, Vegetation, and Grading** - Cover soils in all areas appeared to be adequate. No exposed waste was observed. Vegetation is established over most of the south and west portions of the landfill. The vegetation has stabilized the steep slopes. The grades at the top of the most recent working area are satisfactory. The grades along the south slope are greater than 3:1.

5. **Drainage and Erosion Control** - Stormwater from the site collects in a low-lying area to the south of the landfill via overland flow and a large rip-rap swale, where it percolates into the ground. The access roadway on the north side of the landfill was repaired during the last quarter, but again eroded (see site plan area 2). CRAA will notify the contractor that a repair is necessary. The large rip-rap swale along the southeast side of the landfill is in good condition, but overgrown in some places with brush. The brush will be monitored and removed as necessary to allow for proper function of the swale. A small amount of erosion was again observed at the top of the southern slope. However, no repair is necessary at this time (see site plan area 3).

- INSPECTION NOTES**
- ① WASTE LOCATION BEYOND PROPERTY LINE
 - ② EROSION IN ACCESS ROAD
 - ③ SMALL AREA OF EROSION TO OBSERVE

2. Repair erosion on access road.

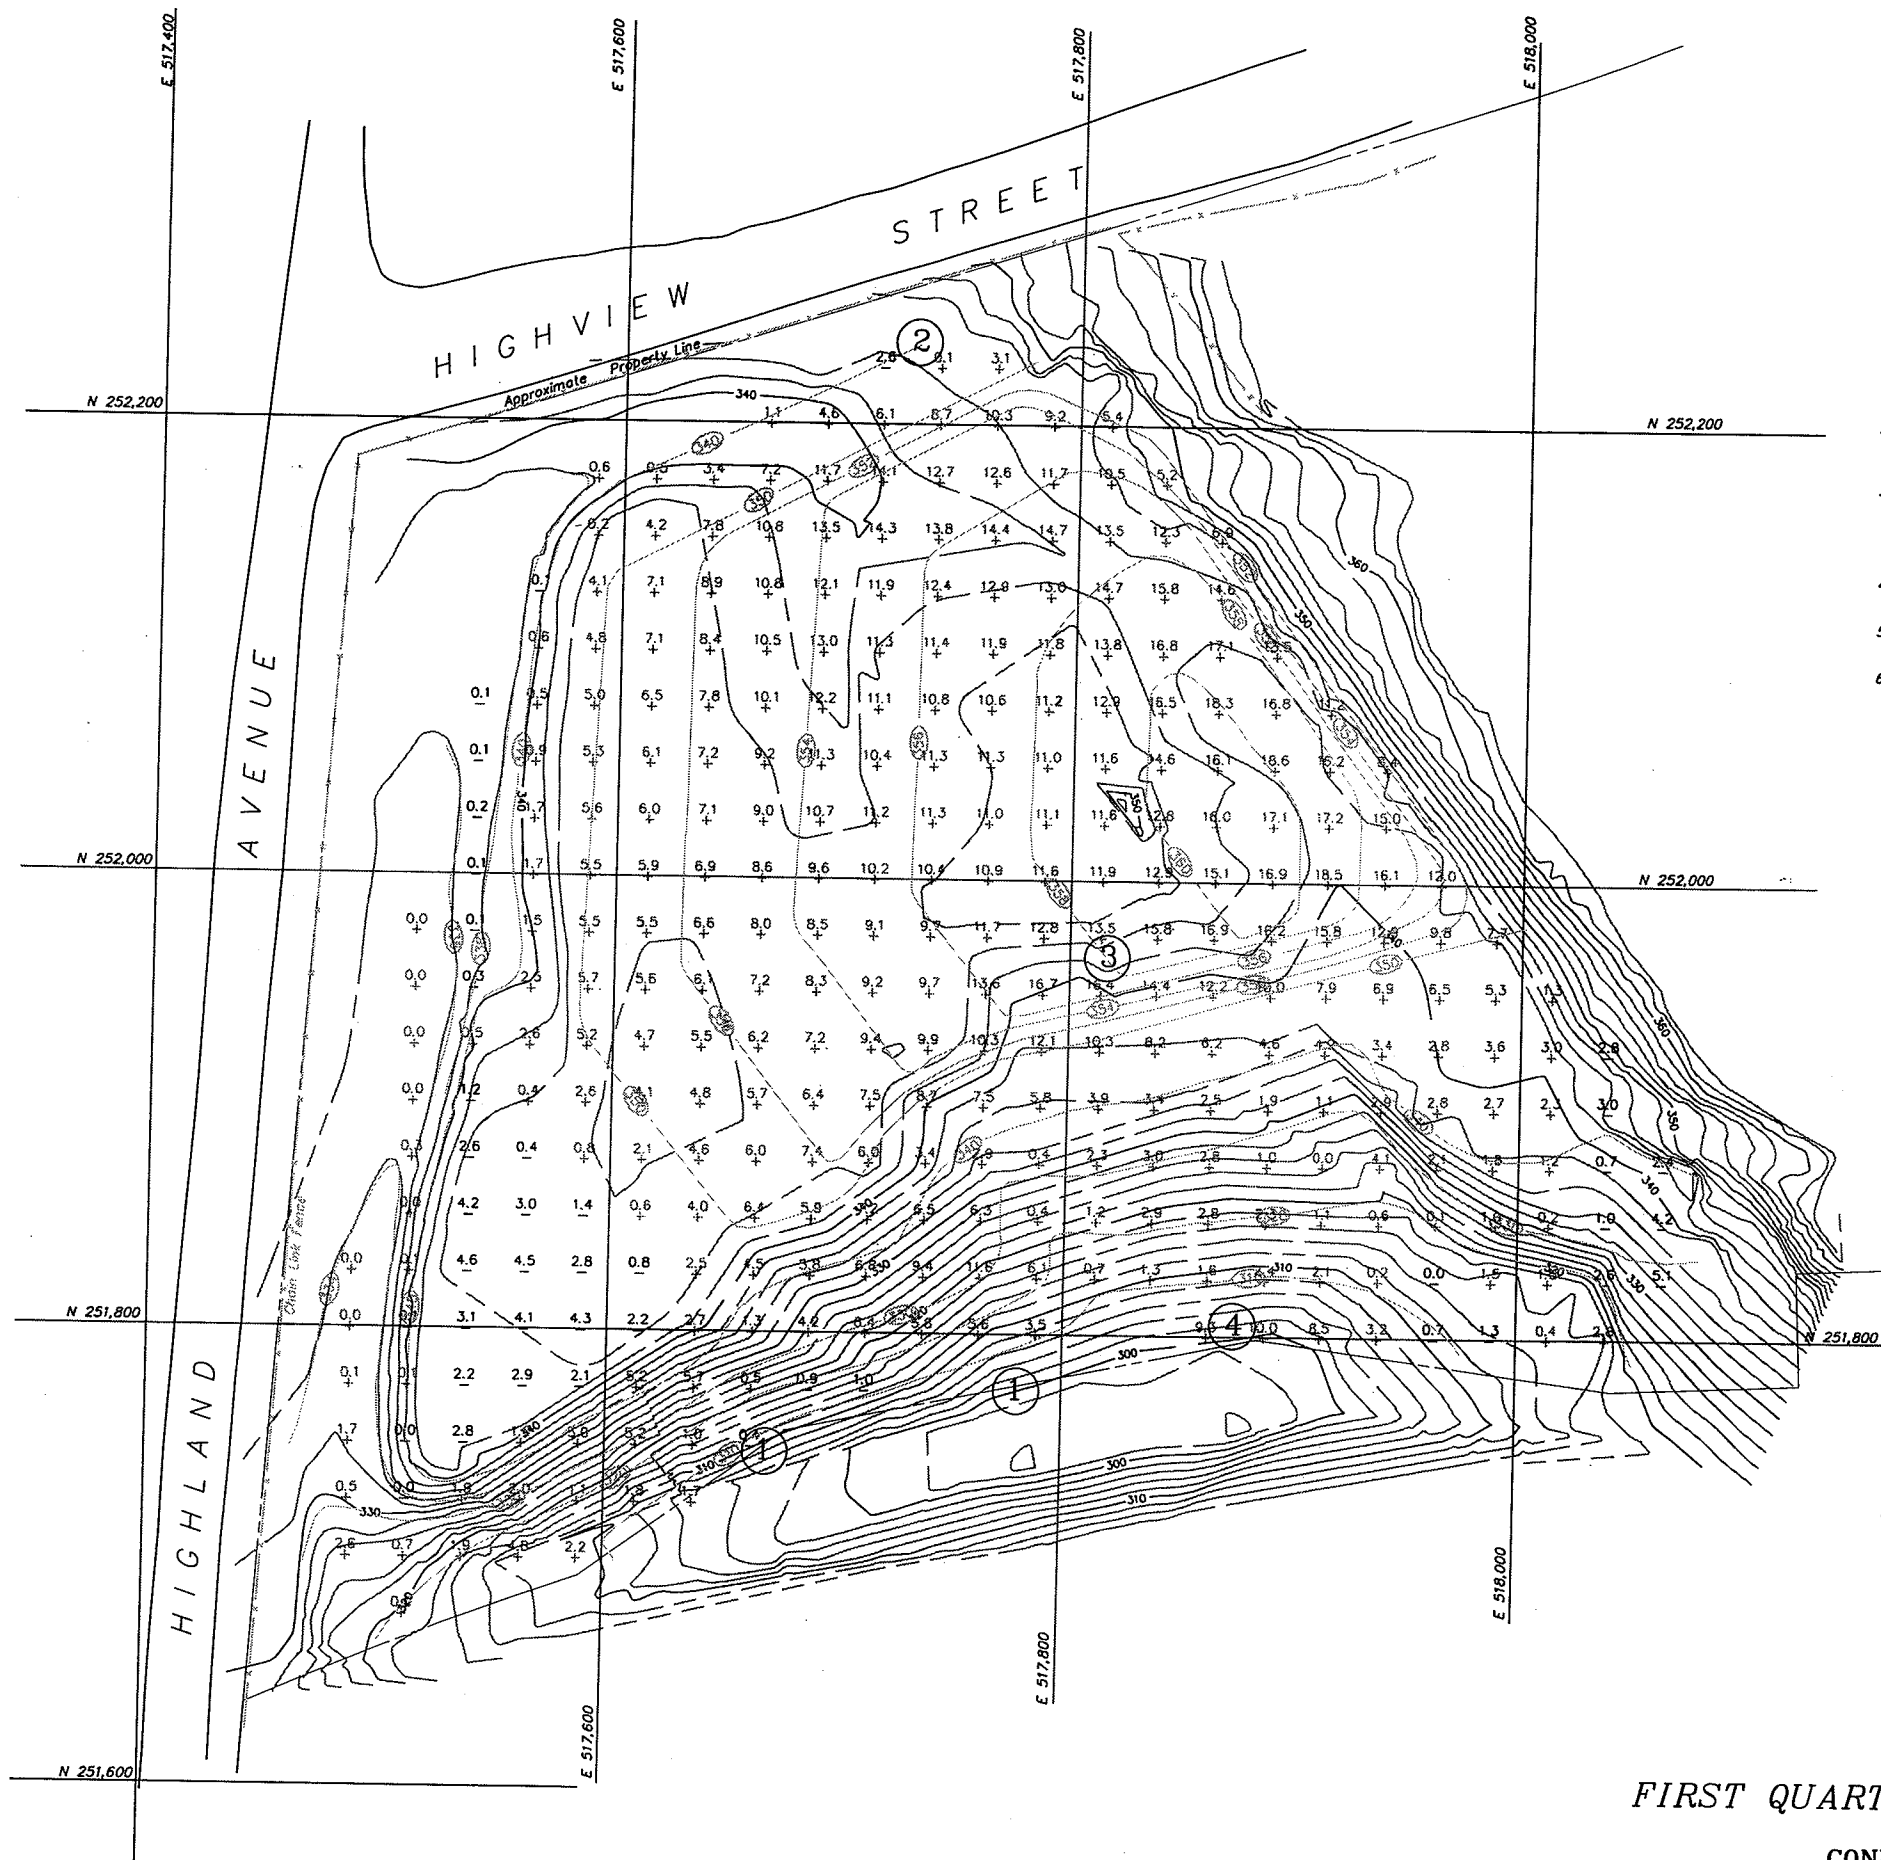
4. **Cover Soils, Vegetation, and Grading** - Cover soils in all areas appeared to be adequate. No exposed waste was observed. Vegetation is established over most of the south and west portions of the landfill. The vegetation has stabilized the steep slopes. The grades at the top of the most recent working area are satisfactory. The grades along the south slope are greater than 3:1.

5. **Drainage and Erosion Control** - Stormwater from the site collects in a low-lying area to the south of the landfill via overland flow and a large rip-rap swale, where it percolates into the ground. The access roadway on the north side of the landfill was repaired during the last quarter, but again eroded (see site plan area 2). CRAA will notify the contractor that a repair is necessary. The large rip-rap swale along the southeast side of the landfill is in good condition, but overgrown in some places with brush. The brush will be monitored and removed as necessary to allow for proper function of the swale. A small amount of erosion was again observed at the top of the southern slope. However, no repair is necessary at this time (see site plan area 3).

6. **Leachate Seeps** - No leachate seeps were observed during the inspection. An area of slight orange staining was observed at the toe of the south slope (see site plan area 4).

- ① WASTE LOCATION BEYOND PROPERTY LINE
- ② EROSION IN ACCESS ROAD
- ③ SMALL AREA OF EROSION TO OBSERVE
- ④ AREA OF STAINING TO OBSERVE

2. Repair erosion on access road.
